Manhole Inspection Summary

Manhole # S45U__029MH

Insp Date: **3/6/08 3:14 PM**

Location Address: **1200 Cooksie Street**

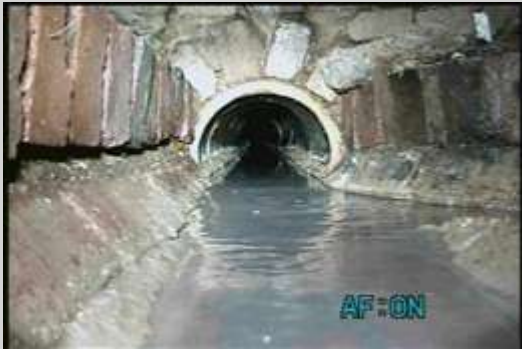
12 O'Clock Outflow

8 in. Circular Gravity Sewer
Pipe Out @ 12 O'Clock

Pipe Height: (in.) Direct
Pipe Material: **Clay** ☐ Pipe Lined
Invert Depth: **7.33** (ft.) Flow Characteristics: **Slow**
Deposits: ☒ None ☐ Mud ☐ Sludge ☐ Debris ☐ Grease
Silt Depth: (in.) Deposits Extent:
Infiltration: **None** Pipe Seal Cond: **Unknown**

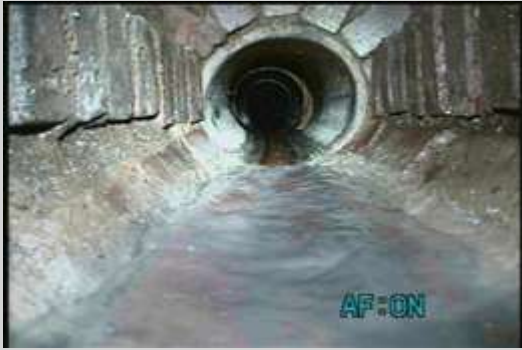
6 O'Clock Inflow

8 in. Circular Gravity Sewer

Pipe In @ 6 O'Clock

Pipe Height: (in.) Direct

Pipe Material: **Clay** ☐ Pipe Lined
